Engineering News-Record

Failure of Apishapa Dam, Colorado

Failure of Apishapa Earth Dam in Colorado—II

Two Independent Reports Written After Investigations and Interviews at Site Agree that Failure Was Due to Conditions in Body of Earth Fill

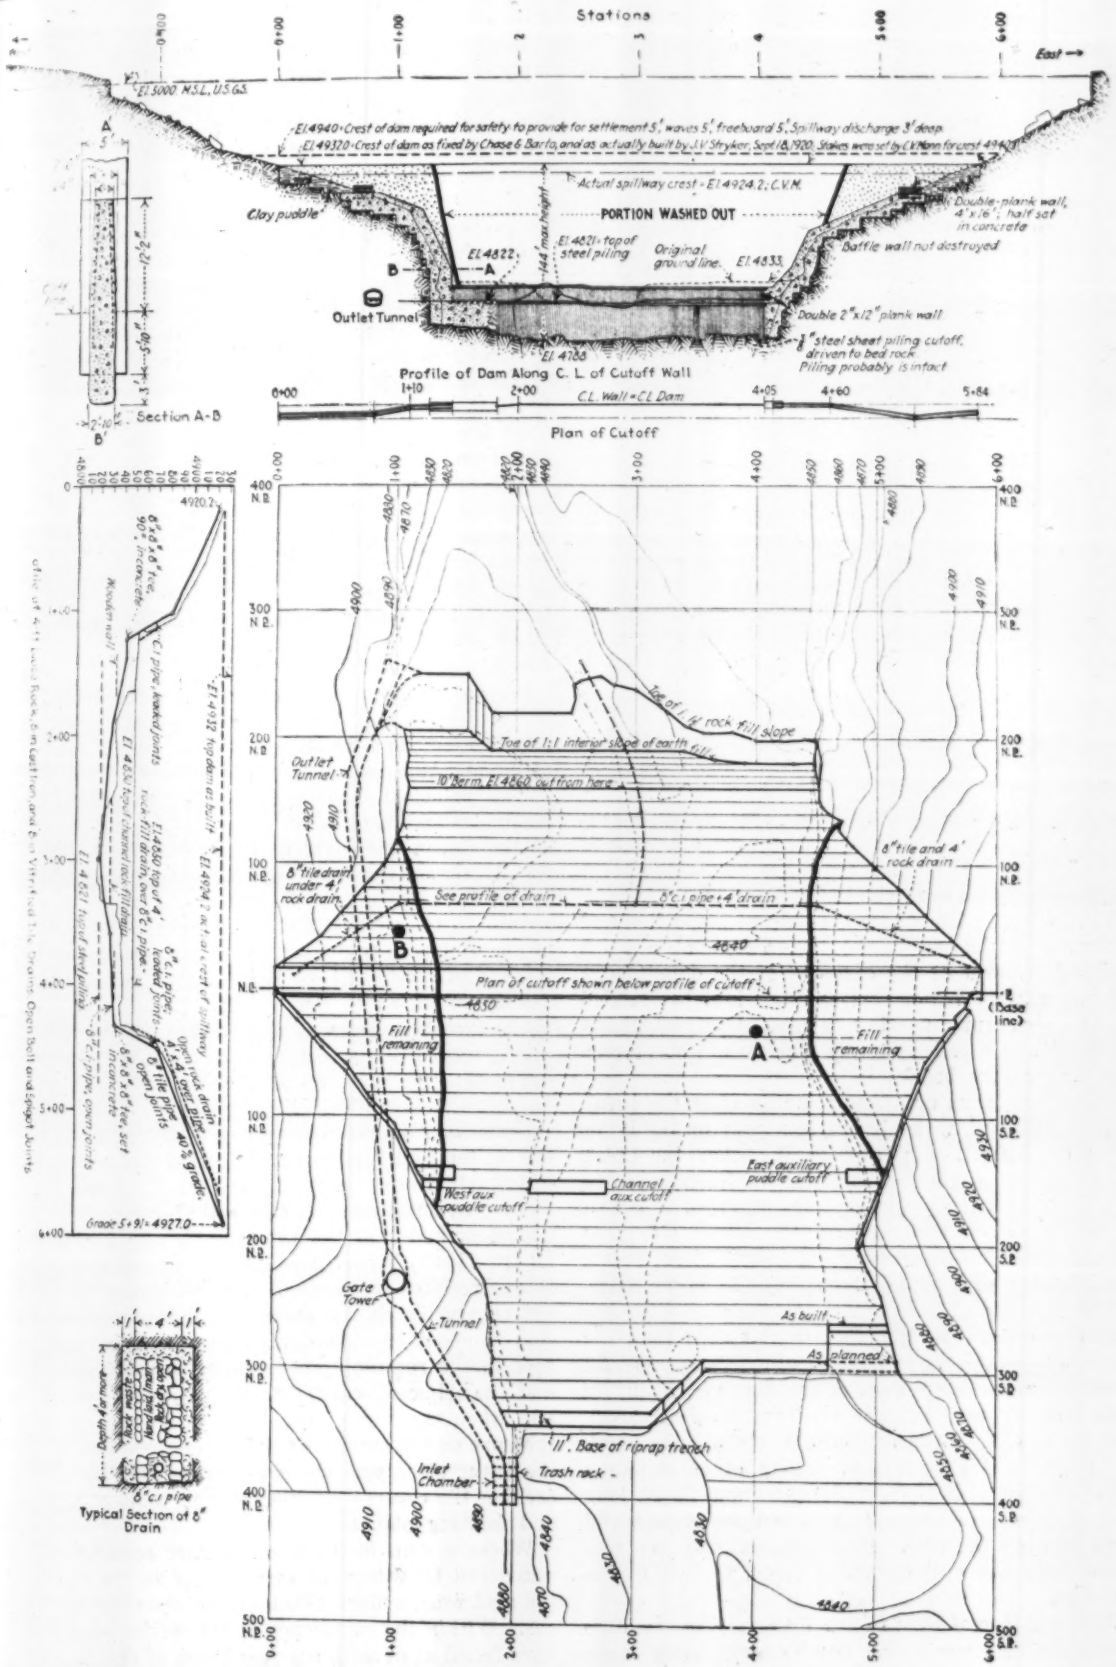
Stations
East →
El. 5000 M.S.L., U.S.G.S.
El. 4940 - Crest of dam required for safety to provide for settlement 5', waves 5', freeboard 5', Spillway discharge 3' deep.
El. 4932.0 - Crest of dam as fixed by Chase & Barto, and as actually built by J.V. Stryker, Sept. 18, 1920. Stakes were set by C.V. Mann for crest 4940.
Actual spillway crest - El. 4924.2, C.V.M.
PORTION WASHED OUT
Clay puddle
El. 4822
El. 4821 - top of steel piling
144' max. height
Original ground line
El. 4833
Double-plank wall, 4' x 16', half set in concrete
Baffle wall not destroyed
Outlet Tunnel
El. 4788
Double 2" x 12" plank wall
½" steel sheet piling cutoff, driven to bed rock. Piling probably is intact
Profile of Dam Along C. L. of Cutoff Wall
C.L. Wall = C.L. Dam
Section A-B
Plan of Cutoff
Toe of 1:1 rock fill slope
Toe of 1:1 interior slope of earth fill
Outlet Tunnel
10' Berm, El. 4860 out from here
8" tile and 4' rock drain
8" tile drain under 4' rock drain

See profile of drain
8" C.I. pipe in 4' drain
Plan of cutoff shown below profile of cutoff
Fill remaining
Fill remaining
East auxiliary puddle cutoff
West aux puddle cutoff
Channel aux. cutoff
Gate Tower
Tunnel
As built
As planned
11' Base of riprap trench
Inlet Chamber
Trash rack
Grade 5+91 = 4927.0
Typical Section of 8" Drain
Contour Plan of Dam, Based on Topography by C.V. Mann, 1919

The Failure—There were at the dam during the week of the failure about thirty men, including Mr. Knowlton, an engineer-contractor and a landowner in the project, and Mr. Dallimore, the engineer of the system. These men were being employed in miscellaneous work but particularly in repairing a small leak near the west end of the dam and in filling in some settlement areas and cracks near the point marked *B* on the plan shown herewith.

At 2:45 Mr. Dallimore made a trip of inspection and observed a settlement at the water edge at a point about 100 ft. west of the east end of the dam (Point A of the plan). Water was running into the settled area and apparently passing downward into the body of the dam. He called for his workmen, who started to try to stop the break.

At the same time or a few minutes after the break was first observed, water began to appear on the lower slope some 500 ft. west and 30 ft. below the crest. This point [*B* on plan] was about 60 ft. east of the point where repairs had been in progress. Almost immediately after the leak on the lower side was observed, wet spots appeared on the lower slope, first a short distance east of the break on the lower slope, and then in rapid succession wet spots appeared further to the east, each a little higher in the slope than the last. The flowing water rapidly ate back on the fill diagonally up the lower face of the dam and finally to a point immediately opposite the first observed break in the water side. Desperate efforts to choke the break were made by the workmen; among other things a galvanized steel tank 6 ft. in diameter and 20 ft. long was rolled into the hole. It held but an instant and passed through the hole. It is apparent the dam was doomed from the moment water began to flow in the lower side.

The cavities apparently extended from near point *A* some distance within the dam from the upper slope diagonally across the center line to a point nearly 400 ft. westerly, where the water broke through the lower slope. The cavities were doubtless connected by a longitudinal crack as the break on the upper face was followed within a few minutes by the appearance of flowing water on the lower face.
